Preliminary Summary Report

Re: Stephanie Wadsworth & Matthew Wadsworth v. Walmart, Inc & Jetson Electric

Location of Loss: 1620 HWY 374, Green River, WY

Service Requested: Case Review/ Computer Fire Modeling and Fire Dynamics Review

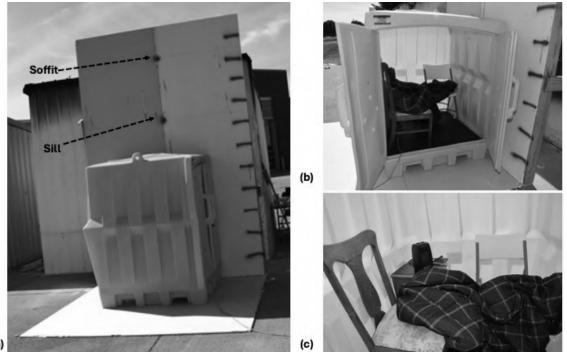
end table in the southeast corner, a metal chair in the southwest corner, and a comforter/blanket (Figure 8).²¹ Based on the fire test of the shed, the peak heat release rate was approximately 3,000-5,000 kW, which reached this peak in approximately 400-450 seconds, assuming a flaming ignition of the comforter (Figure 7). This fire could have smoldered before transitioning into flaming combustion due to the type of fuels and potential ignition sources. Research has been conducted on the length of time it takes for a cigarette to transition from smoldering to flaming combustion, which states "this transition from smoldering to flaming does not occur in all cases; when it does, times from placement of the cigarette to flaming of *22 minutes to several hours* have been reported".²² Flame heights exceeded 20 feet (6.1m).

Figure 8: Test Setup (note: two 12-ft sheets of drywall are positioned behind the storage shed) (a) exterior, (b) interior with chairs & comforter/blanket, (c) interior corner with end table & heater

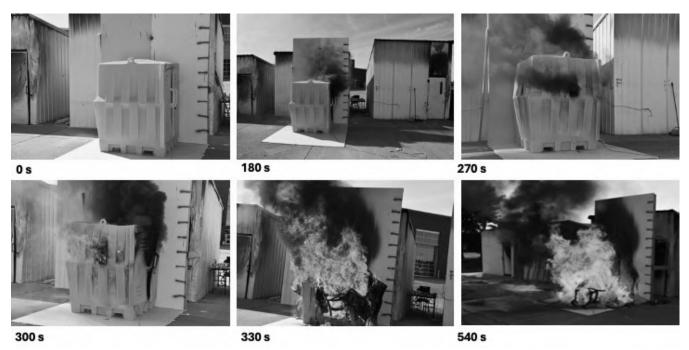
Figure 9: Fire Test Results (note: the fire was extinguished ~9.5 minutes [570s] due to fire spreading to surrounding structures; pool fire continued to burn with flame heights ~4-5ft)

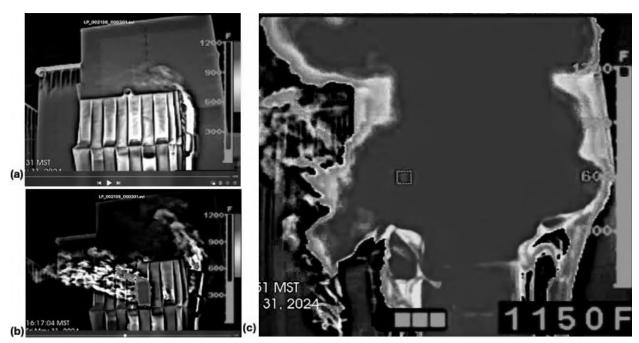
Figure 10: Thermal Imaging Camera Results (a) ~180s, (b) ~300s, (c) ~400s

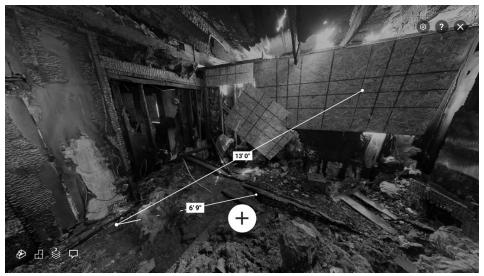
All early eyewitnesses mentioned the window and wall behind the bunk bed in bedroom #4, located ~13 feet away from the hoverboard, had ignited early in the event and that the bunk bed had not.⁶⁶ The energy required to ignite the wall behind the bed and cause the window to fail ~13 ft from the hoverboard was assessed (Figure 17).

Figure 17: Matterport scan with dimensions from hoverboard location to the corner of the bunk bed (\sim 6.75 ft) and the window (\sim 13 ft).

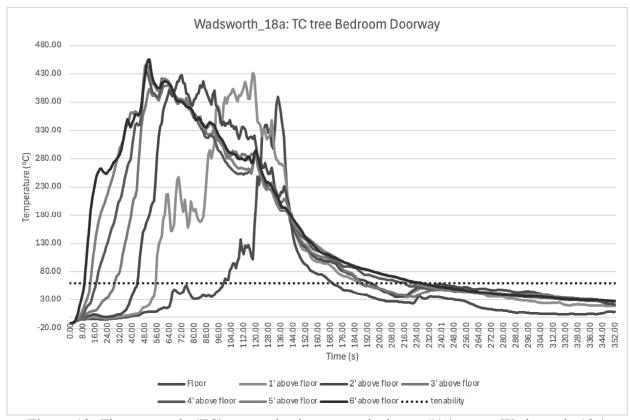
A fire originating at the hoverboard quickly creates temperatures above the tenability criteria for bedroom #4 doorway to the hallway. The temperature criteria were exceeded at the bedroom doorway for both the 6 ft and 3 ft heights within 5-49 seconds. See Figure 18 as a representative example of the temperature data for a thermocouple tree (temperatures at 1-ft intervals from the floor) in the bedroom doorway for bedroom #4. The temperature criteria are reached before the window fails, which is inconsistent with the witness statements and their survivability. Therefore, the egress of Layne and Gunner through the bedroom doorway with an origin at the hoverboard is inconsistent with their explanation of the events the night of the fire and the survivability of the occupants.

Figure 18: Thermocouple (TC) tree at the doorway to bedroom #4 (source: Wadsworth_18a)

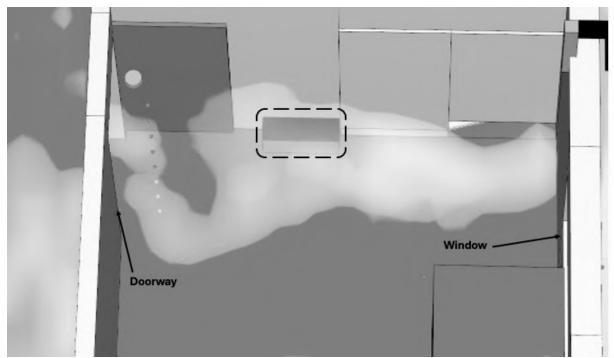
Most of the flaming combustion remains near the hoverboard in the early stages of the fire until flames spread across the wood paneling lining the wall near the hoverboard and then across the compartment through radiant heat transfer, igniting the bunk bed. When the compartment nears full-room involvement and the window has failed, a flow path extends from the window to the open doorway of bedroom #4 (Figure 19). The ventilation-controlled conditions create a path along the north wall where combustion continues post-flashover. Therefore, the extent of damage along the north wall is consistent with ventilation-generated fire patterns along the flow path from the window to the bedroom doorway (Figures 19-21). The damage and fire patterns identified by the fire investigators near the hoverboard result from this flow path from the window to the doorway and are consistent with ventilation-generated fire patterns, not an origin at the hoverboard.

Figure 19: Hoverboard Origin: Bedroom #4 aerial view-location of mixture for flaming combustion within the compartment post-flashover (Note: dashed line is where the hoverboard was located; 130 seconds into the simulation (source: Wadsworth_16))

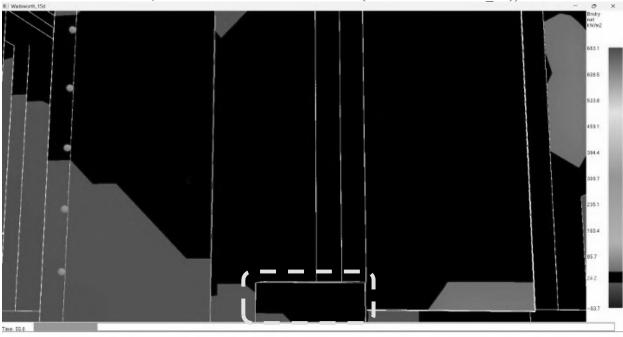
Figure 20: Hoverboard Origin: Heat Flux Boundary Condition in bedroom #4 looking at the north wall (note: dashed line is where the hoverboard was located (source: Wadsworth_15d))

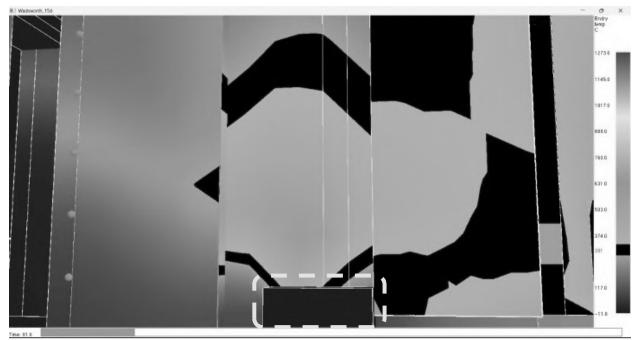
Figure 21: Hoverboard Origin: Wall Temperature Boundary Condition in bedroom #4 looking at the north wall (note: dashed line is where the hoverboard was located (source: Wadsworth 15d))

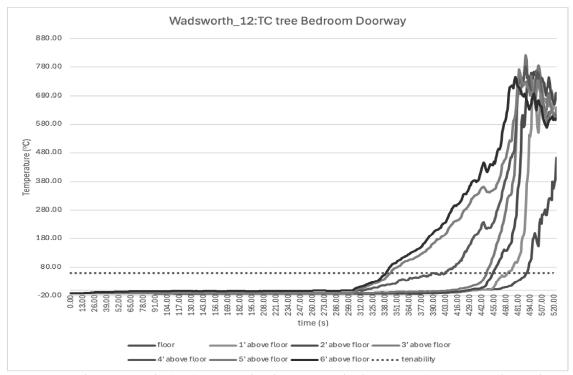
The doorway temperature tenability thresholds are met as bedroom #4 transitions to full-room involvement, which only occurs after the window failure and the fire spreads into bedroom #4. See Figure 21 as a representative example of the temperature data for a thermocouple tree (temperatures at 1-ft intervals from the floor) in the bedroom doorway for bedroom #4.

Figure 22: Thermocouple (TC) tree at the doorway to bedroom #4 (source: Wadsworth 12)

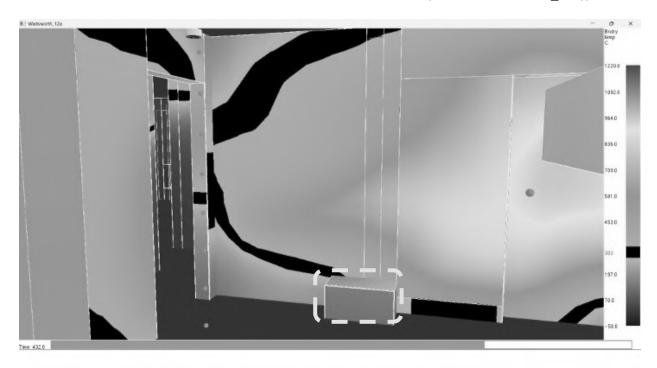
Following the failure of the window and ignition of the bunk bed, most of the combustion remains near the bunk bed and spreads across the compartment through radiant heat transfer and fire spread across the wood paneling. When the compartment nears full room involvement, a flow path extends from the window to the open doorway of bedroom #4 (Figures 23-26). The ventilation-controlled conditions within bedroom #4 create a path along the north wall where combustion continues post-flashover. Therefore, the extent of damage along the north wall is consistent with ventilation-generated fire patterns along the flow path from the window to the bedroom doorway and not an area of origin (Figures 23-26).

Figure 24: Storage "Smoker's" Shed Origin: Wall Temperature Boundary Condition in bedroom #4 looking at the north wall (note: dashed line is where the hoverboard was located (source: Wadsworth_12a))

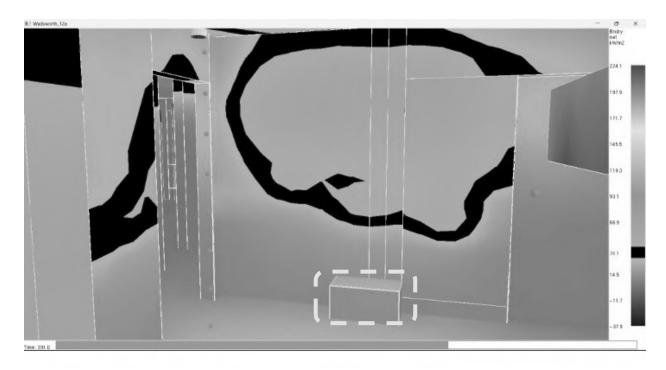
Figure 25: Storage "Smoker's" Shed Origin: Heat Flux Boundary Condition in bedroom #4 looking at the north wall (note: 391 seconds into the simulation; dashed line is where the hoverboard was located (source: Wadsworth_12a))
